Current sensor in Wintershine aquaculture farm

Measuring water circulation in fish tanks

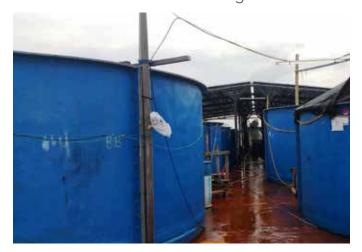
View from inside of barge

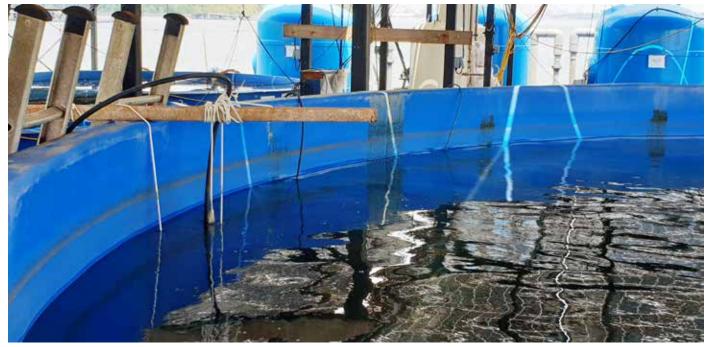
Close view of fisk tank

The tanks at the Wintershine aquaculture facility are designed to perform a self-cleaning process and reduce bacterial growth by subjecting the tank walls to high water velocities. For better control of circulation and fouling effects in the 8m diameter tanks, a robust method to measure

circulation was needed. The DCS was fixed to the tank wall for the test; placed in mid-depth in the 2.5m deep tanks and two of the four transducers were turned off and directed into the flow. The systems worked well and delivered consistent and reliable information on circulation speed.
